# Manhole Inspection Summary

Manhole # S35AA\_015MH

Insp Date: **4/8/08 12:30 PM**

**Location** Address: **10 MADISON ST** Cross Street: **LONG GROVE ST**

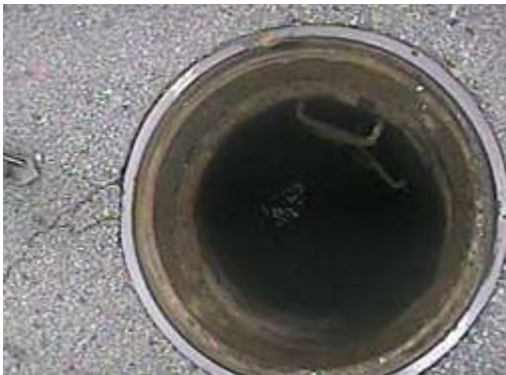
Defect 1

**Frame** Offset: **1** (in.) Condition: ☒ Sound ☐ Cracked ☐ Leaks

FRAME OFFSET

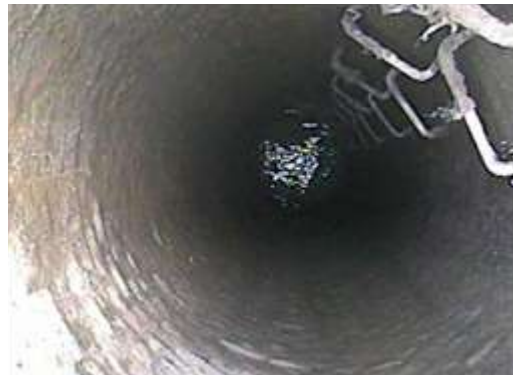
Defect 2

**Steps** Count: **16** Missing: **0** ☒ **Corroded**

CORRODED STEPS

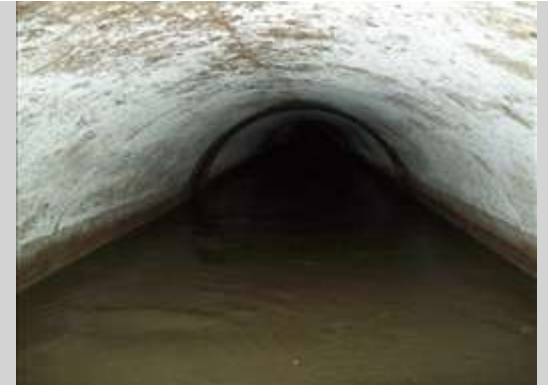
12 O'Clock Outflow

72 in. Circular Gravity Sewer  
Pipe Out @ 12 O'Clock

Pipe Height: (in.) Direct  
Pipe Material: **Concrete** ☐ Pipe Lined  
Invert Depth: **20.58** (ft.) Flow Characteristics: **Slow**  
Deposits: ☒ None ☐ Mud ☐ Sludge ☐ Debris ☐ Grease  
Silt Depth: (in.) Deposits Extent:  
Infiltration: **None** Pipe Seal Cond: **Sound**

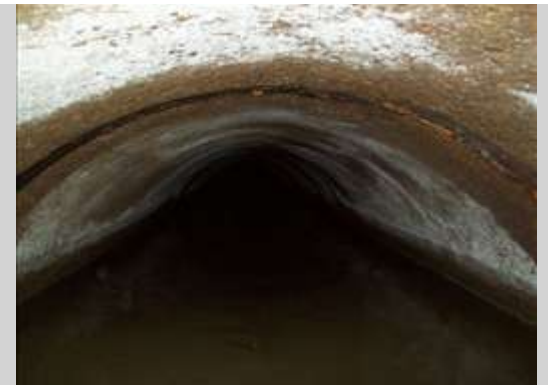
6 O'Clock Inflow

72 in. Circular Gravity Sewer  
Pipe In @ 6 O'Clock

Pipe Height: (in.) Direct  
Pipe Material: **Concrete** ☐ Pipe Lined  
Invert Depth: **20.56** (ft.) Flow Characteristics: **Slow**  
Deposits: ☒ None ☐ Mud ☐ Sludge ☐ Debris ☐ Grease  
Silt Depth: (in.) Deposits Extent:  
Infiltration: **None** Pipe Seal Cond: **Sound**
